# **Debris/Ice/TPS Assessment and Integrated Photographic Analysis of Shuttle mission STS-104**

Armando Oliu  
Process Engineering/Mechanical System Division/ET-SRB Branch,  
Kennedy Space Center, Florida

**July 12, 2001**

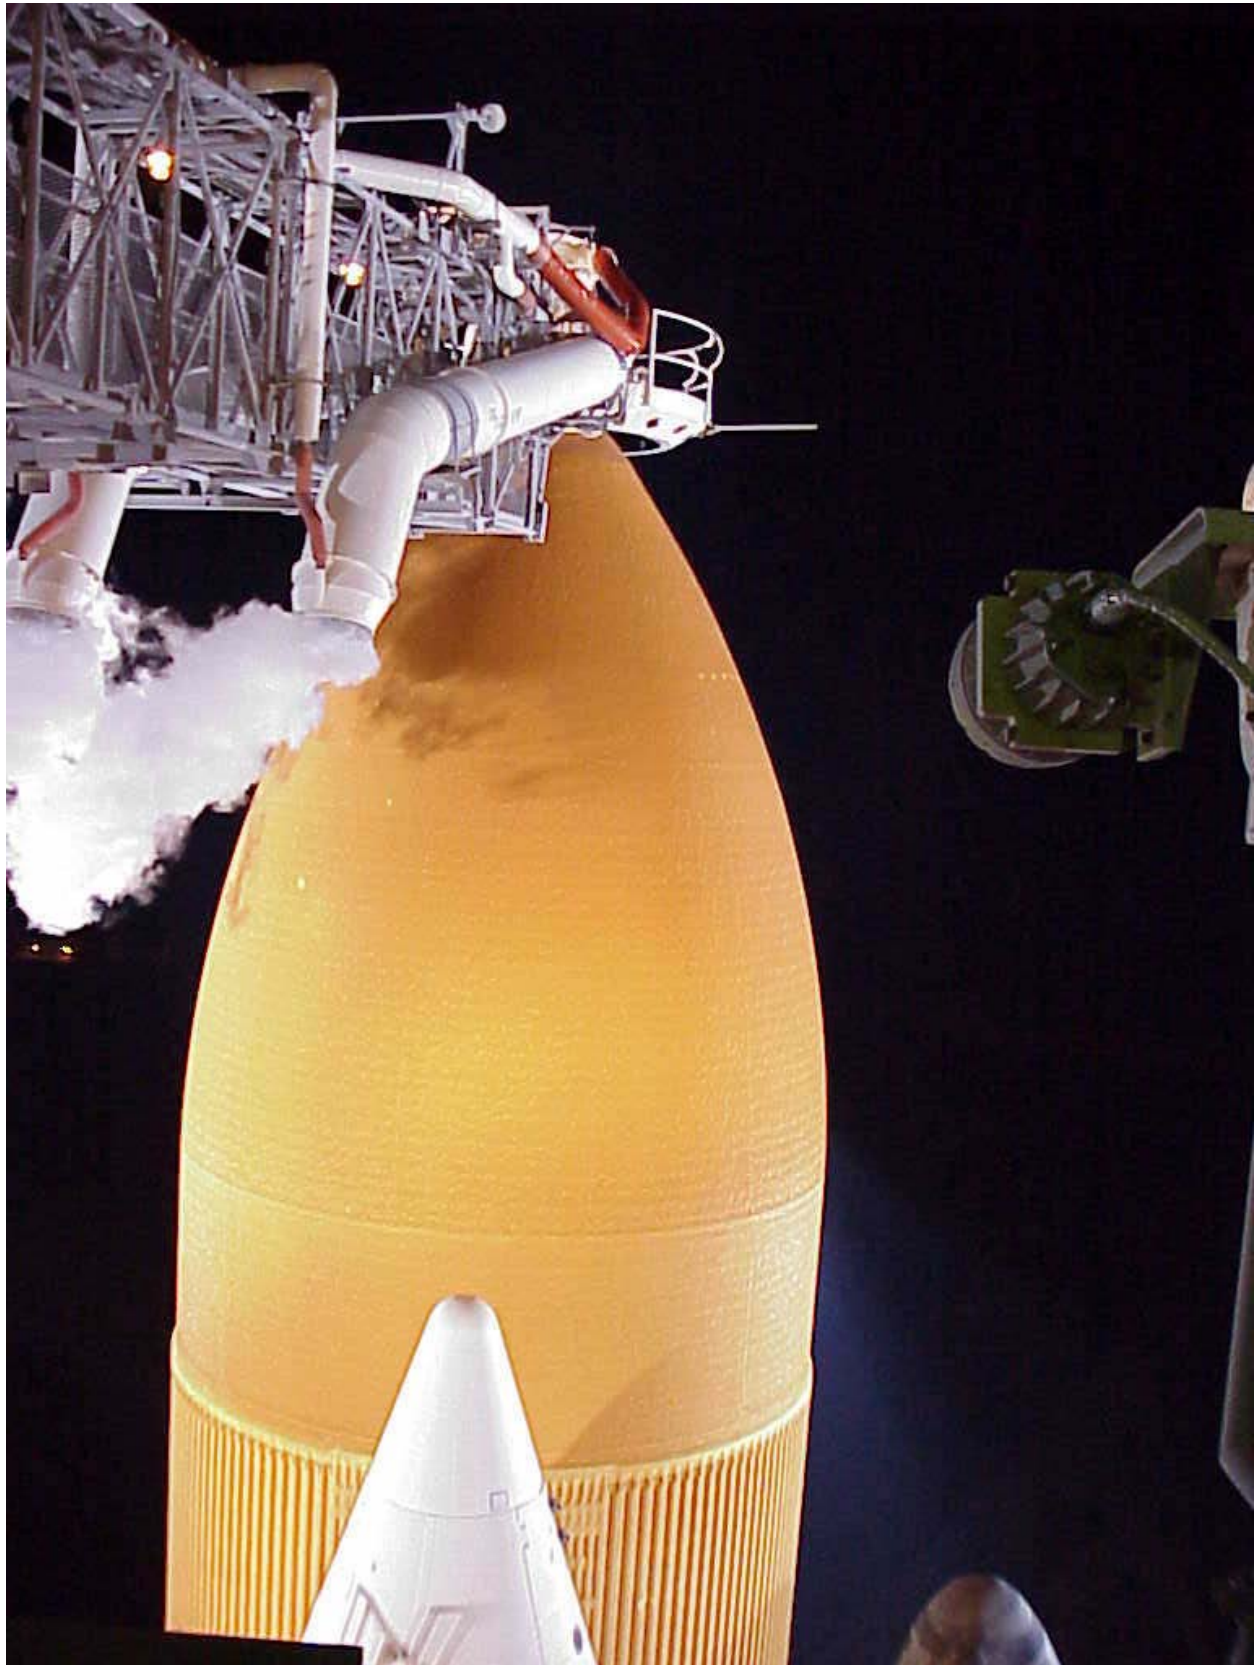
**Photo 2: LO2 tank acreage.**

No condensate was present on the LO2 tank acreage. Surface temperature ranged from 62 to 66 degrees Fahrenheit. There were no acreage TPS anomalies.

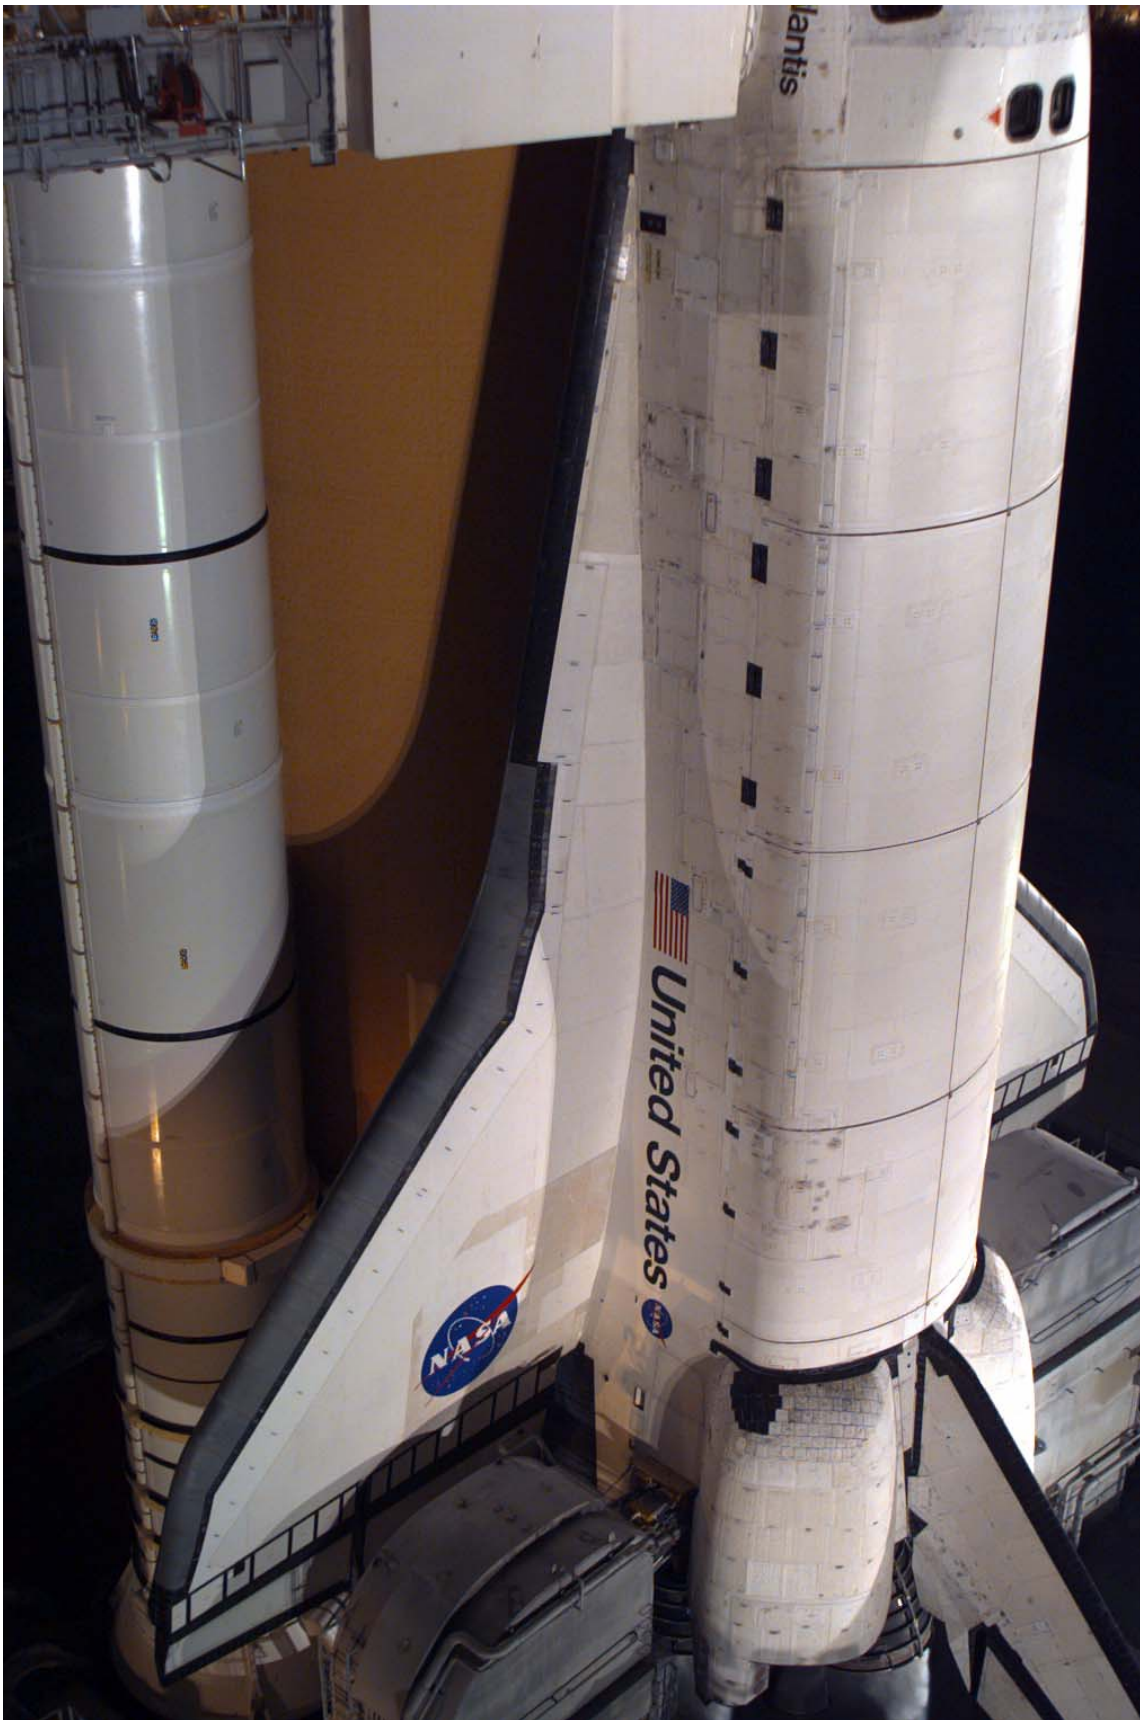
**Photo 3: LH2 tank acreage.**

No condensate was present on the LH2 tank acreage. Surface temperature ranged 58 to 68 degrees Fahrenheit. There were no acreage TPS anomalies.

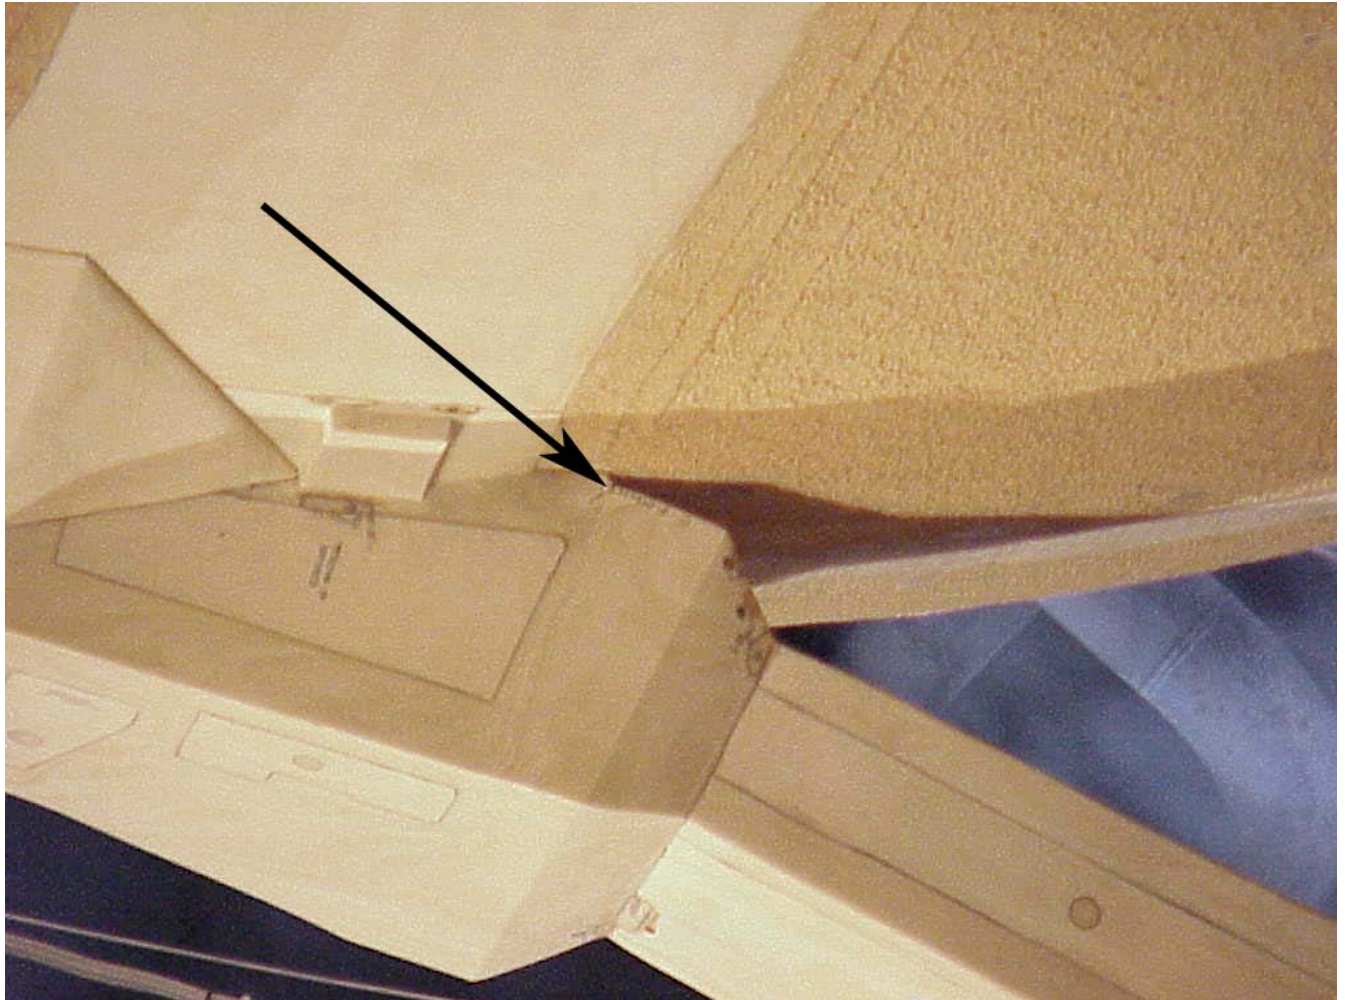
**Photo 4: Crack in -Y Vertical Strut TPS**

A 1 to 1 ½ inch long and .25 inch wide stress relief crack was observed in the –Y vertical strut TPS with no offset. This condition has been observed on previous vehicles and found acceptable for flight per the NSTS-08303 criteria.

A 1 to 1-1/2 inch long and 0.25 inch wide stress relief crack was observed in the -Y vertical strut TPS with no offset. This condition has been observed on previous vehicles and found acceptable for flight per the NSTS-08303 criteria.

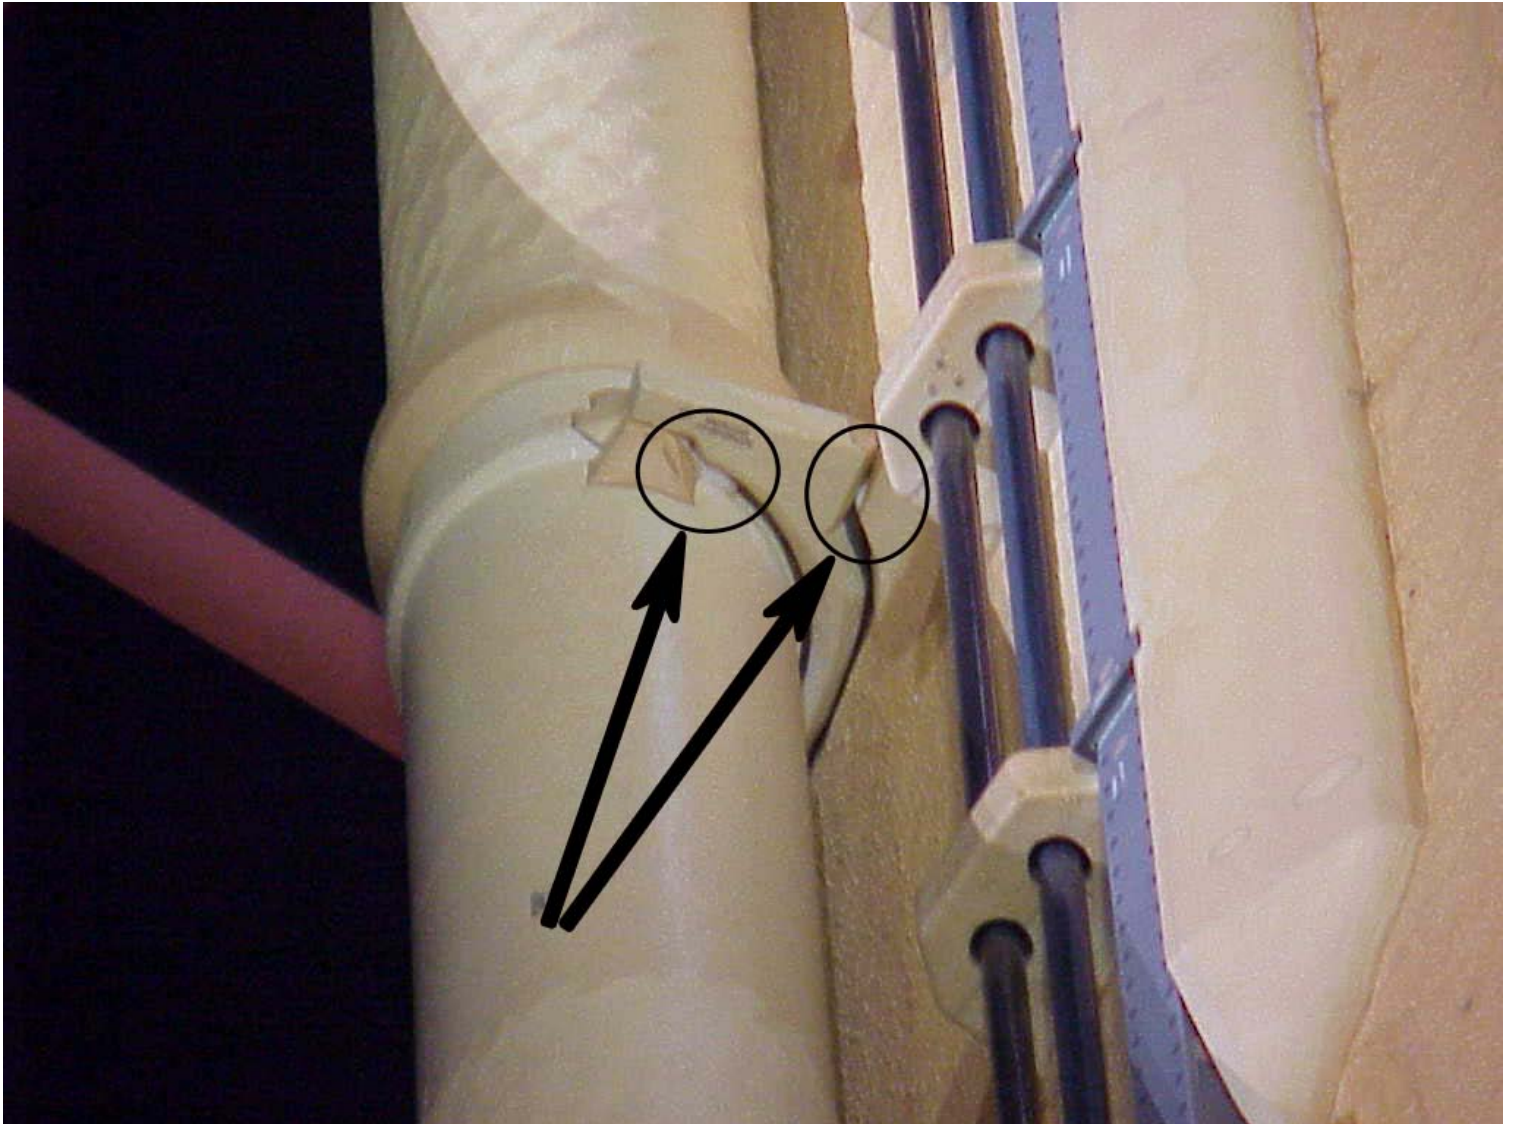
**Photo 5: Ice/Frost on LO2 F/L bracket**

Typical amounts of ice/frost had accumulated in the LO2 feedline bellows and support brackets.

Typical ice/frost on the LO2 feedline support bracket attachments.

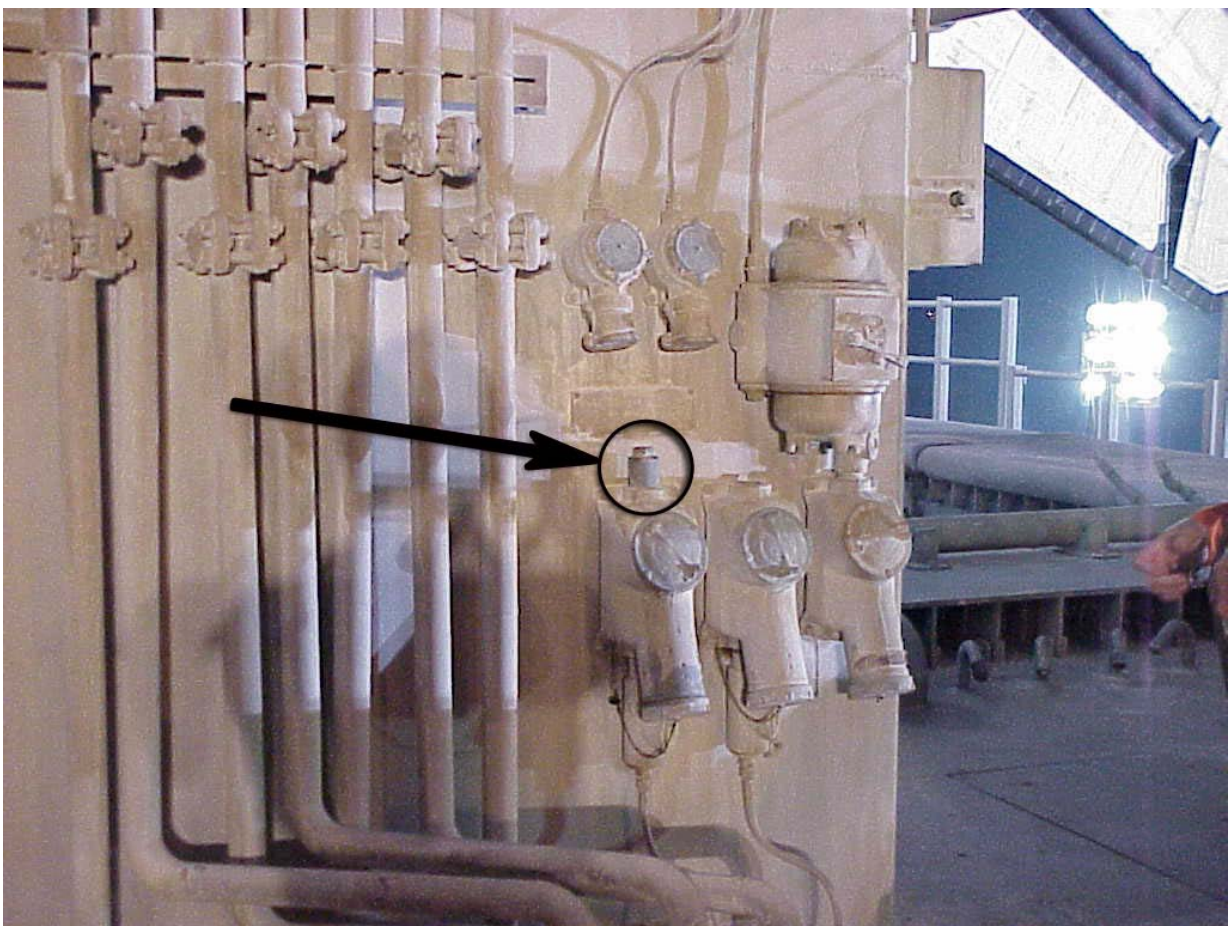
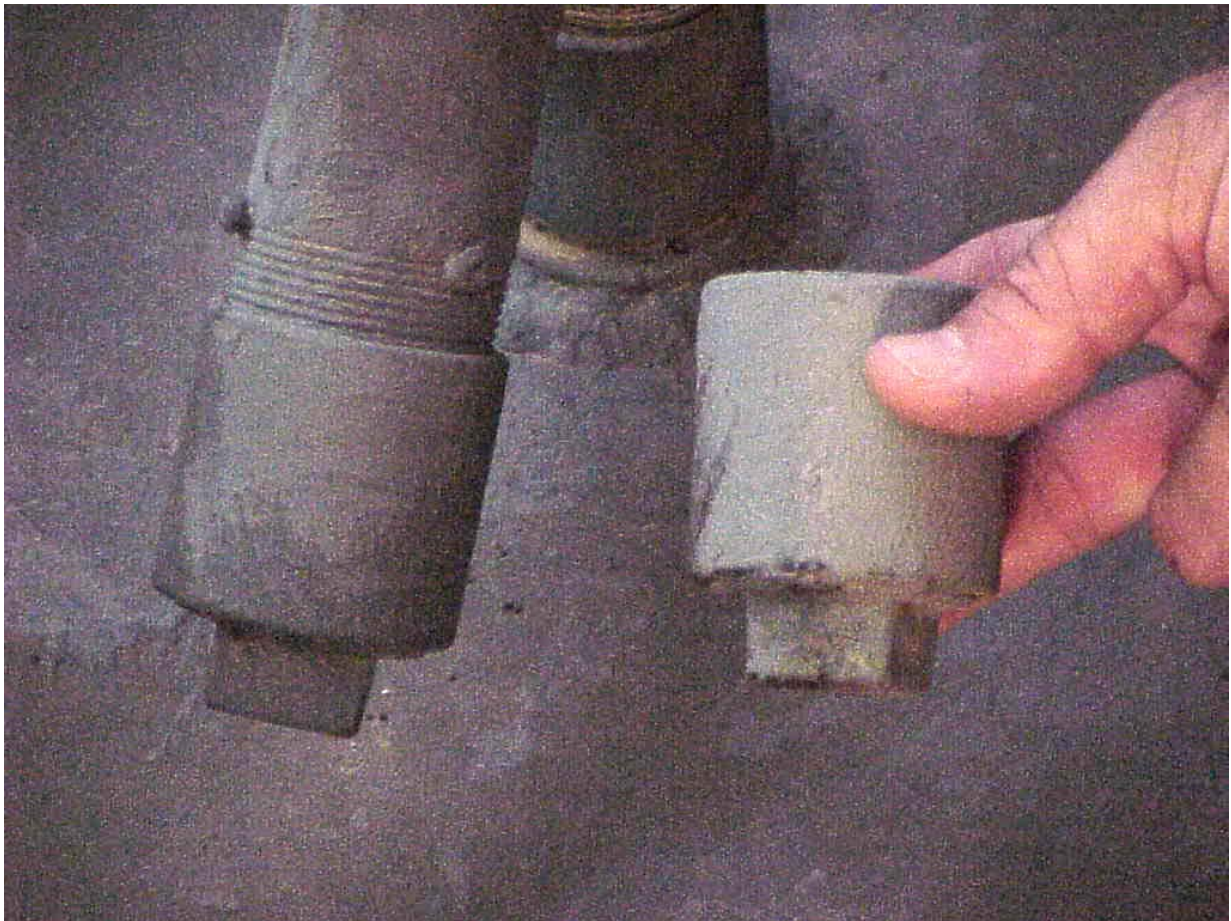
**Photo 6: Facility pipe-end cap.**

All SRB sound suppression water troughs were filled and properly configured for launch. No leaks were observed on the GUCP or the LO2 and LH2 Orbiter T-0 umbilicals. One facility pipe end cap was found on the west side of the LH2 TSM during the walkdown. This debris was removed and an entry was made in Appendix M of S0007. All MLP facility stub-ups were inspected to assure that the end cap was not missing from them. All end caps were verified to be in place and secured.

A pipe-end cap was found on the west side of the LH2 TSM.

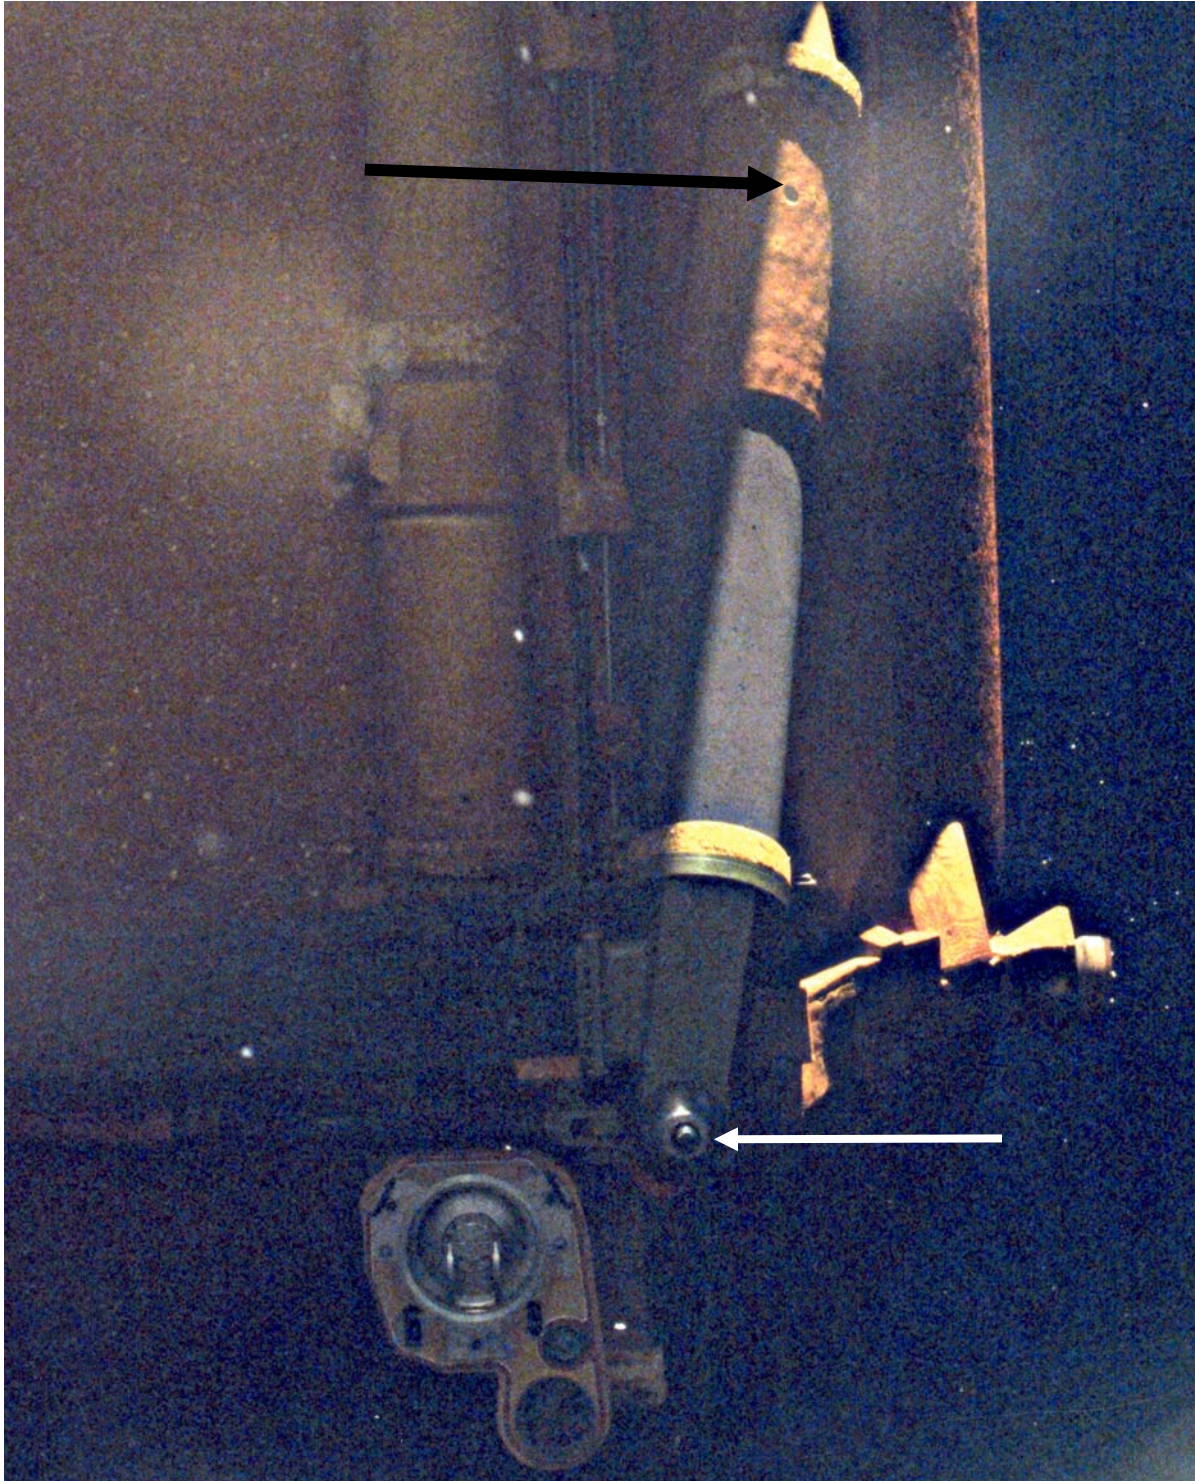
**Photo 7: External Tank post separation**

The EO-3 (LO2 side) separation bolt protrusion was noted. Protrusion appeared to be less than EO-3 bolt protrusion observed on STS-106 film.

A shallow circular TPS divot, approximately two inches in diameter, was observed near the fwd end of the +Y thrust strut.

A shallow, 2-inch divot noted on the +Y thrust strut. The EO-3 separation bolt is protruding slightly.

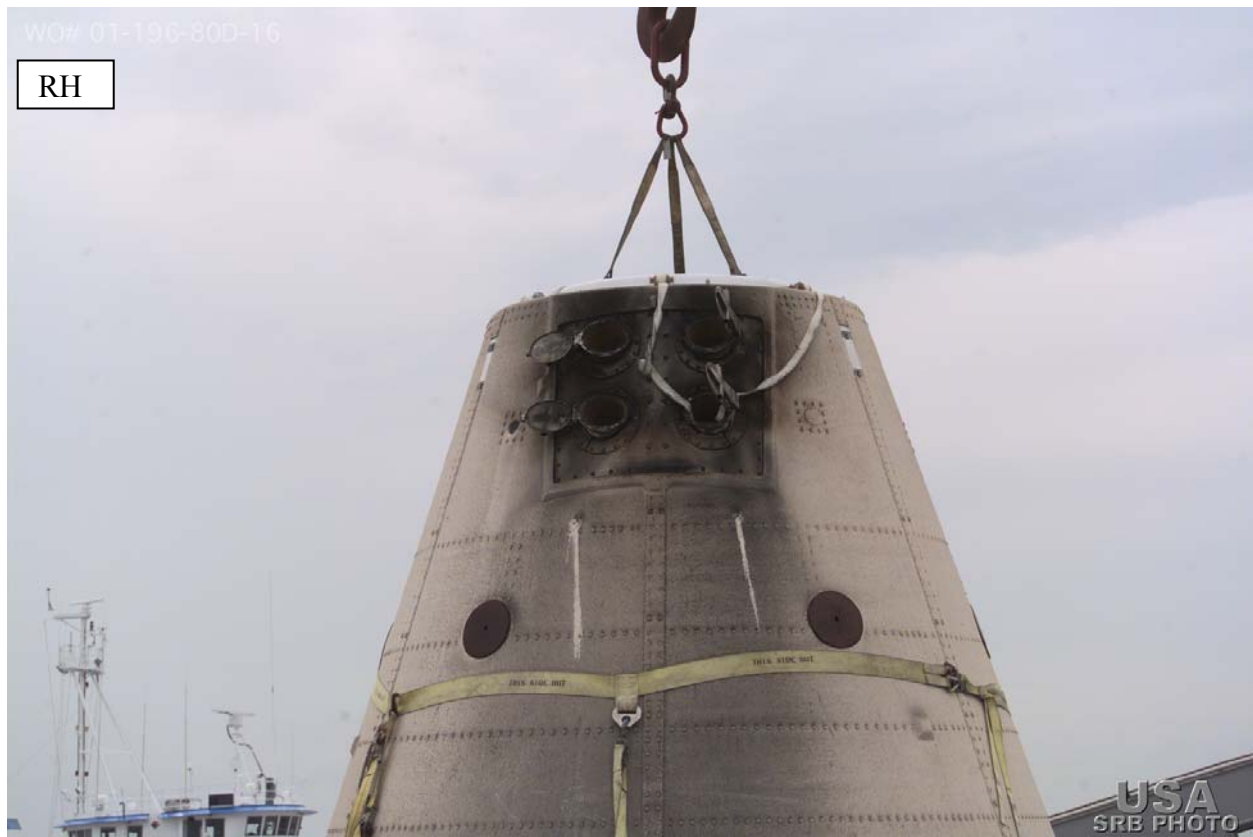
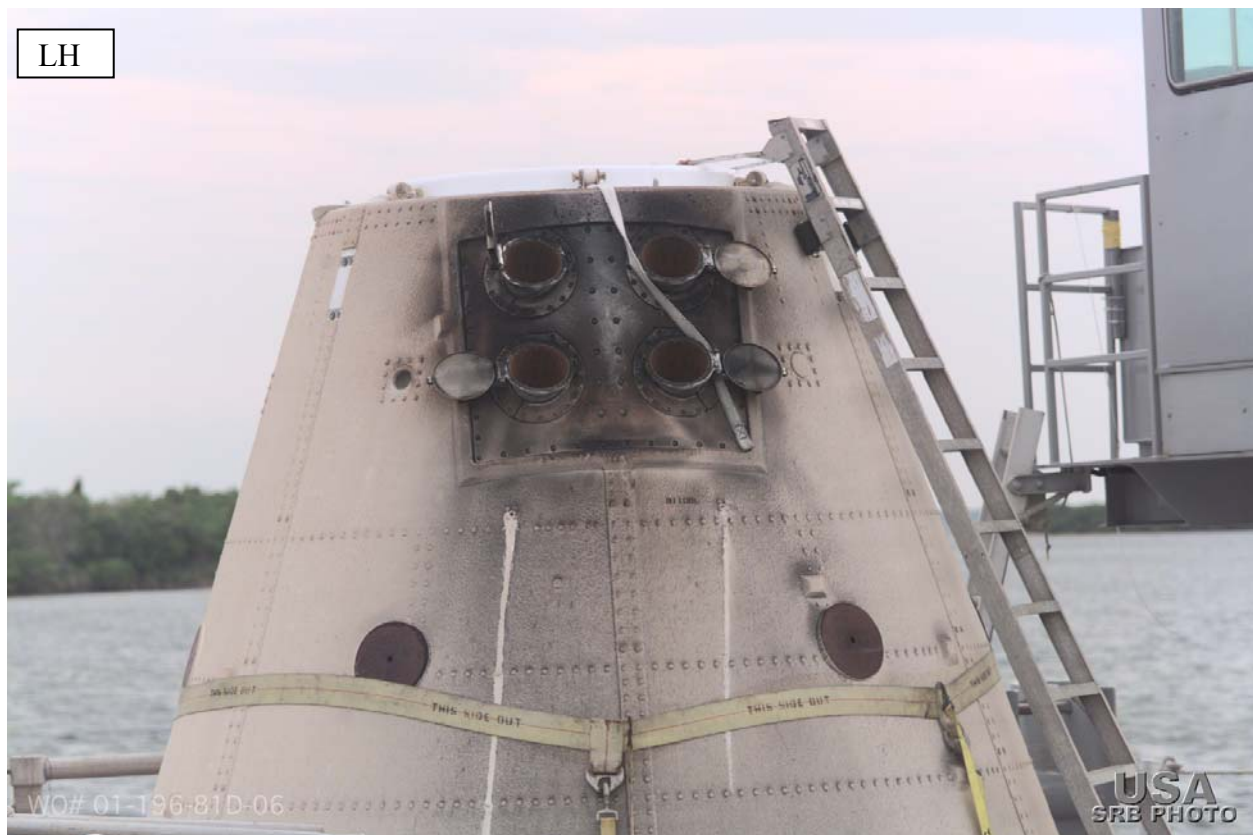
**Photo 8: Frustum Post Flight Condition**

The frustums exhibited no debonds/unbonds or missing TPS.  
All eight BSM aero heat shield covers had locked, but two RH and one LH cover attach rings were bent due to parachute riser entanglement.

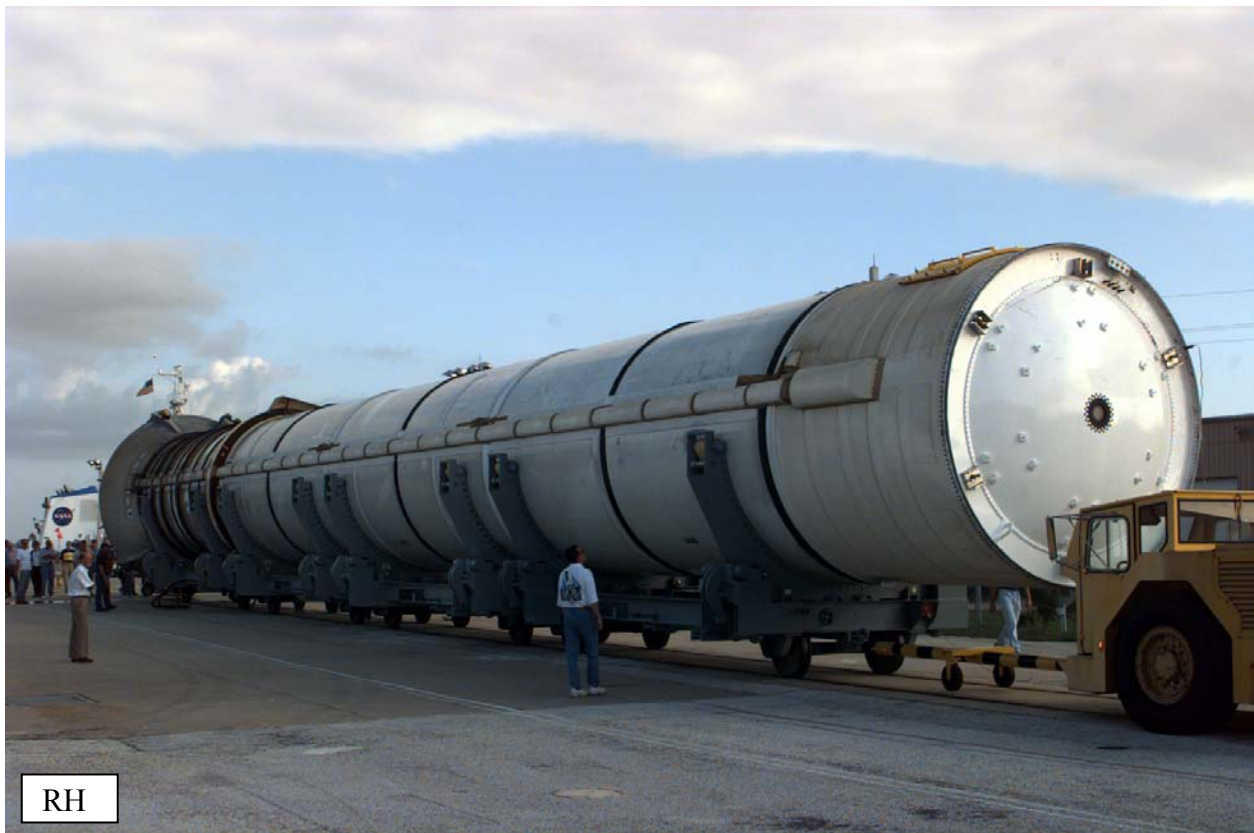
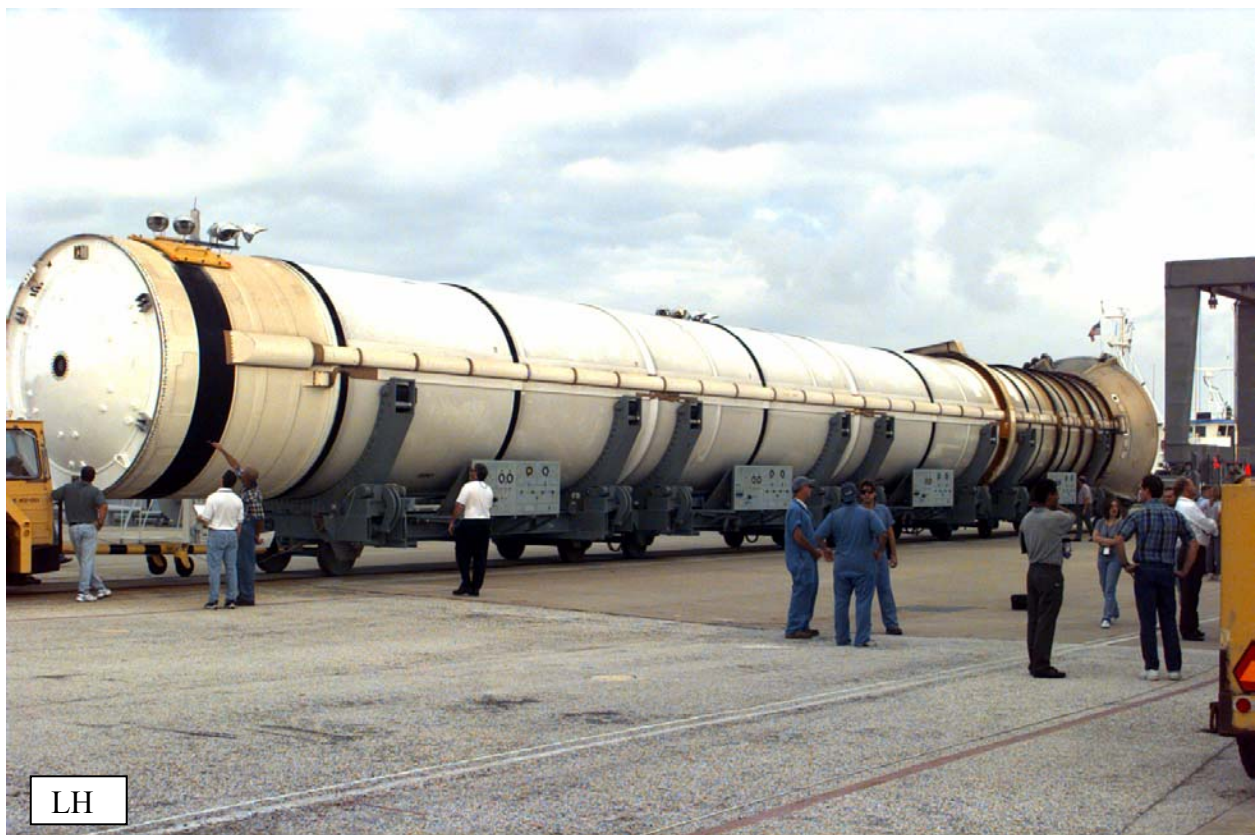
**Photo 9: SRB Post Flight Condition**

Both SRB's were found in good condition regarding debris assessment

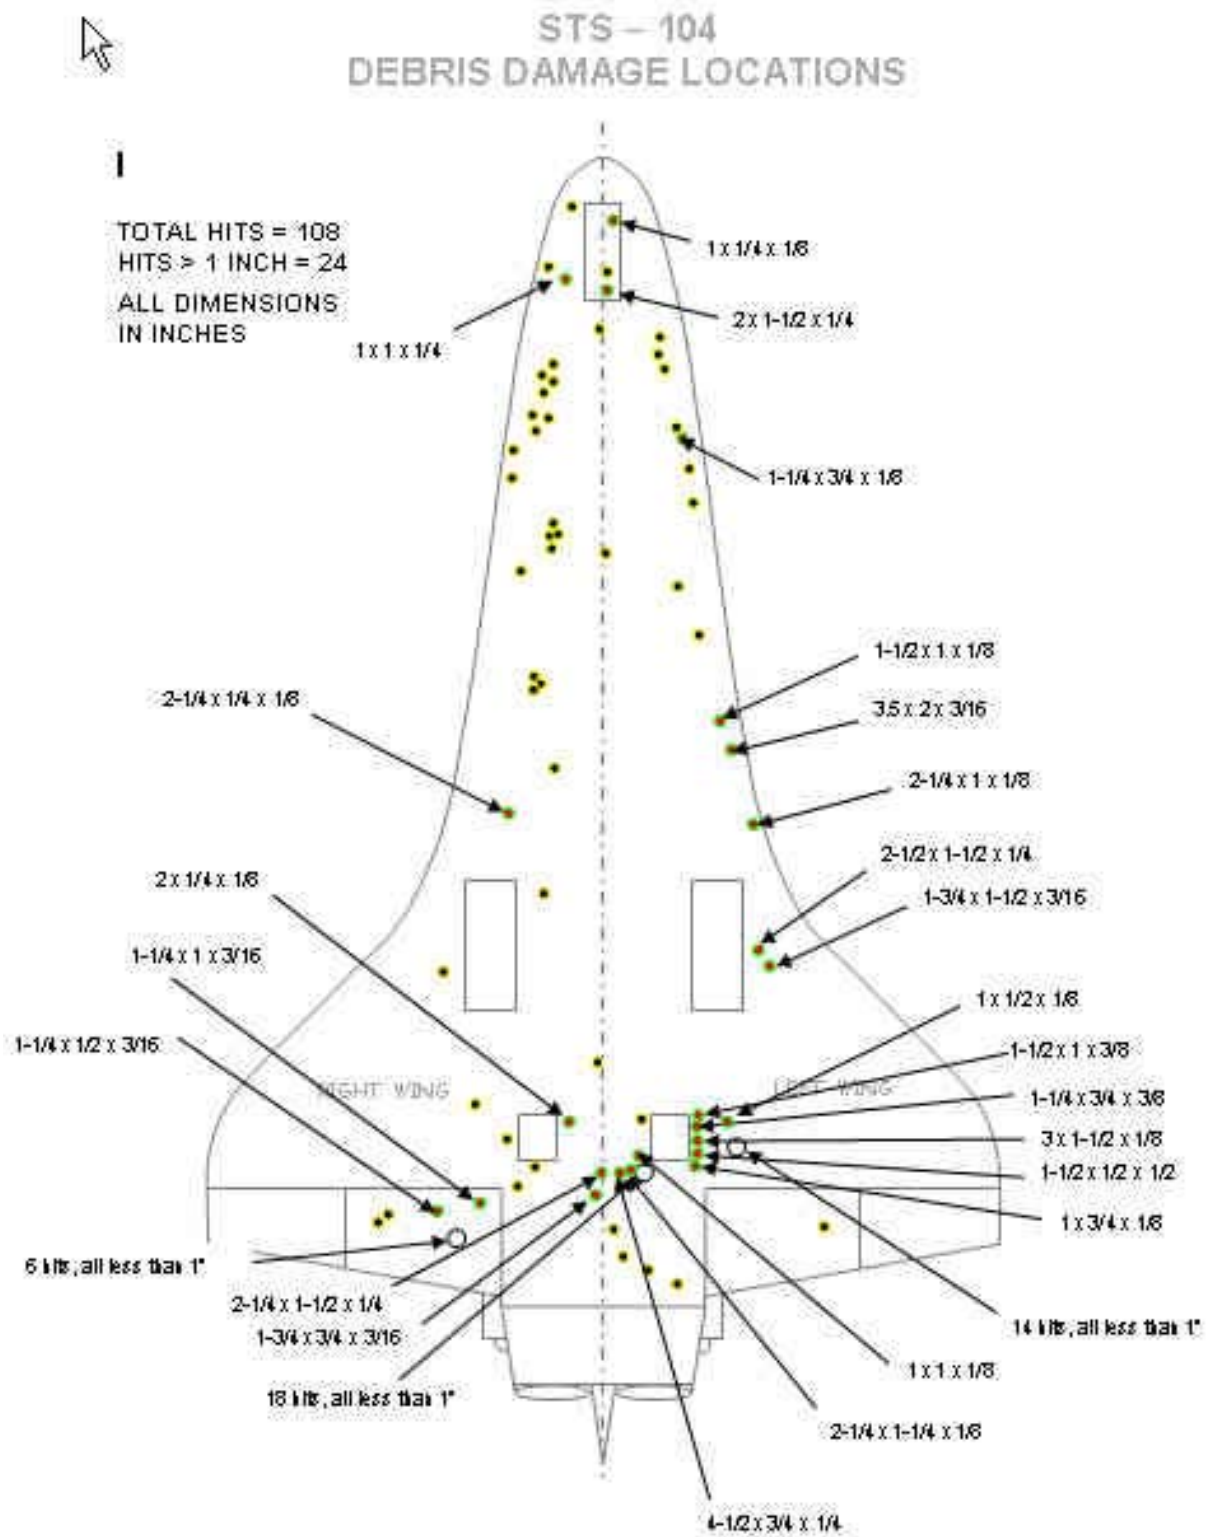
**Figure 1: Orbiter Lower Surface Debris Damage Map**

The orbiter lower surface sustained 108 total hits, of which 24 had a major dimension of 1-inch or larger. Approximately 39 damage sites (with eight larger than 1-inch in length) were located in the area from the nose gear to the main landing gear wheel wells. More damage occurred on the right-hand side of the vehicle than on the left-hand, with a typical pattern, some of these hits may be attributed to impacts from ice in the LO2 feedline bellows. ET TPS venting modifications continue to have a reducing effect on the quantity and size of the damage sites. Analysis of ET separation film may help determine the cause of these hits.

TOTAL HITS = 18  
HITS > 1 INCH = 2  
ALL DIMENSIONS  
IN INCHES

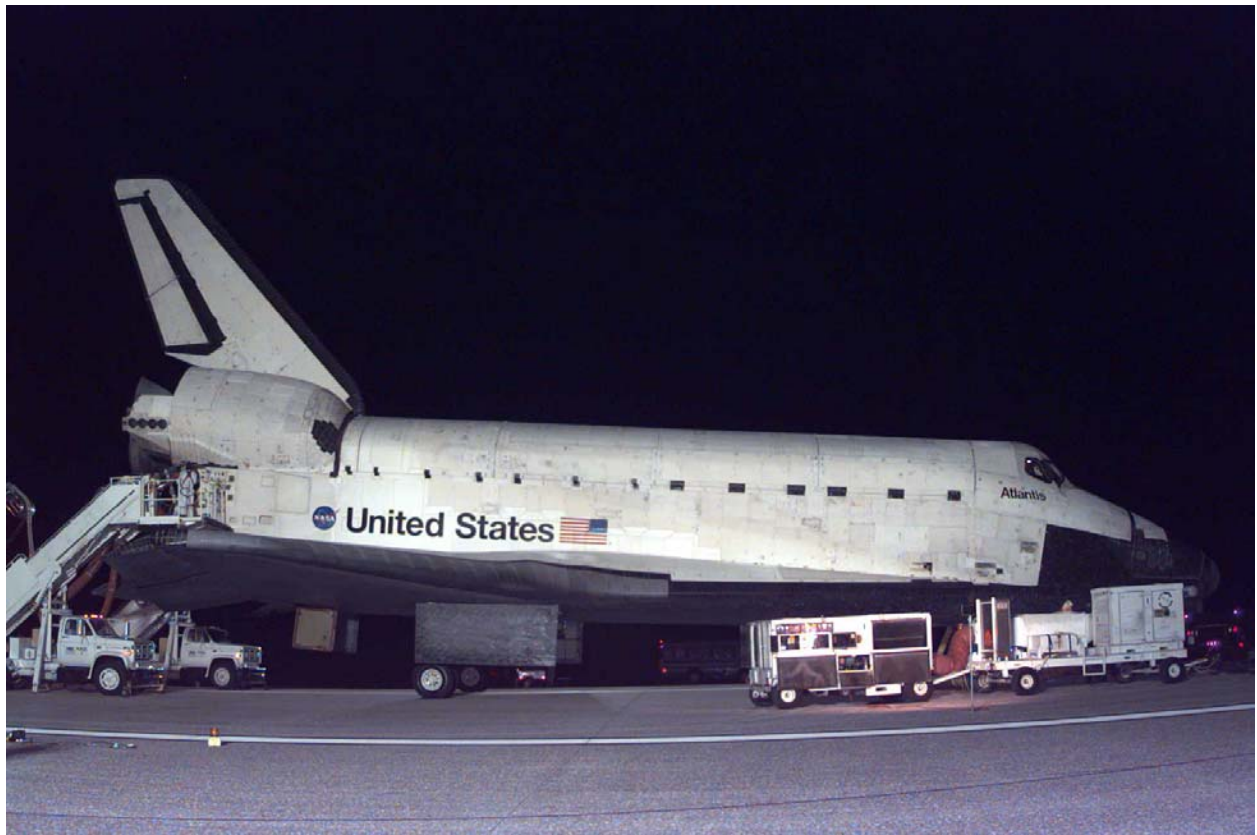
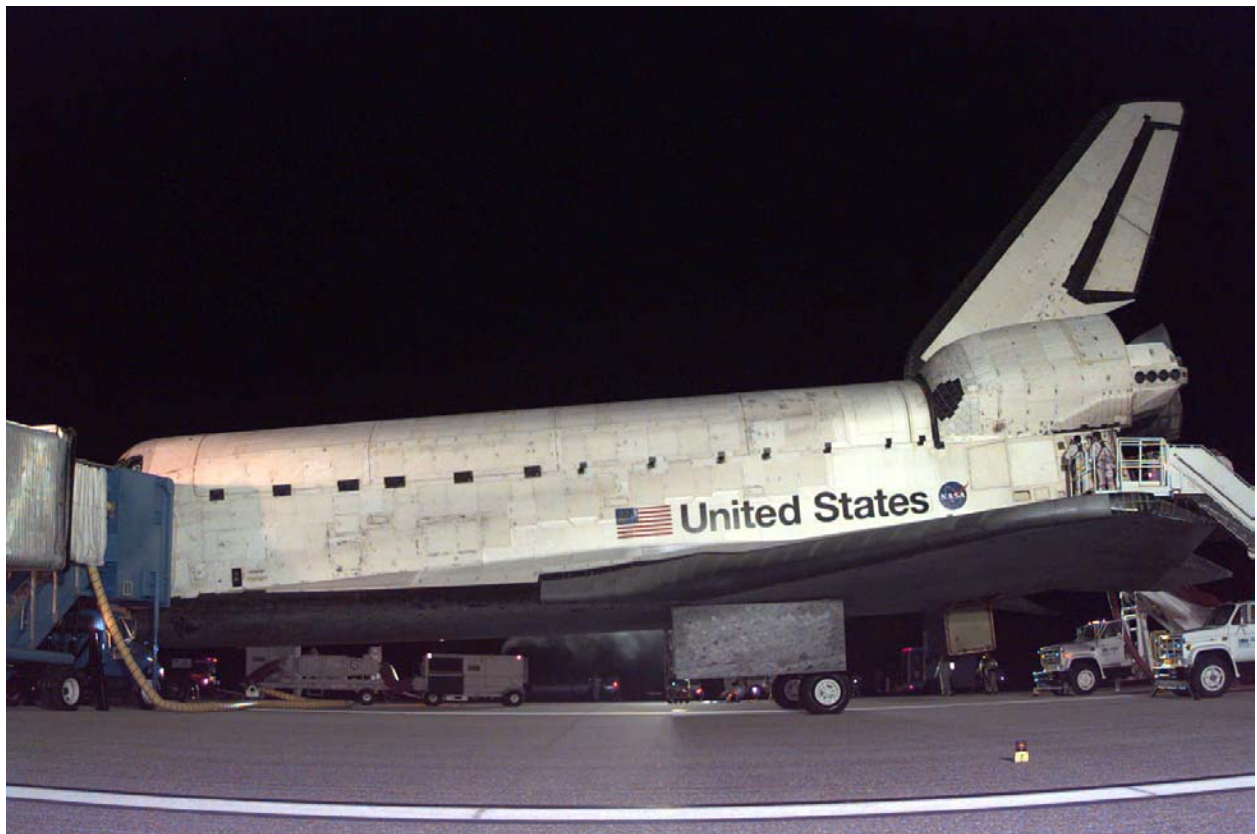
**Photo 10: Overall View of Orbiter**

The orbiter lower surface sustained 108 total hits. Both the total number of Orbiter TPS debris hits and the number of hits 1-inch or larger were within established family.

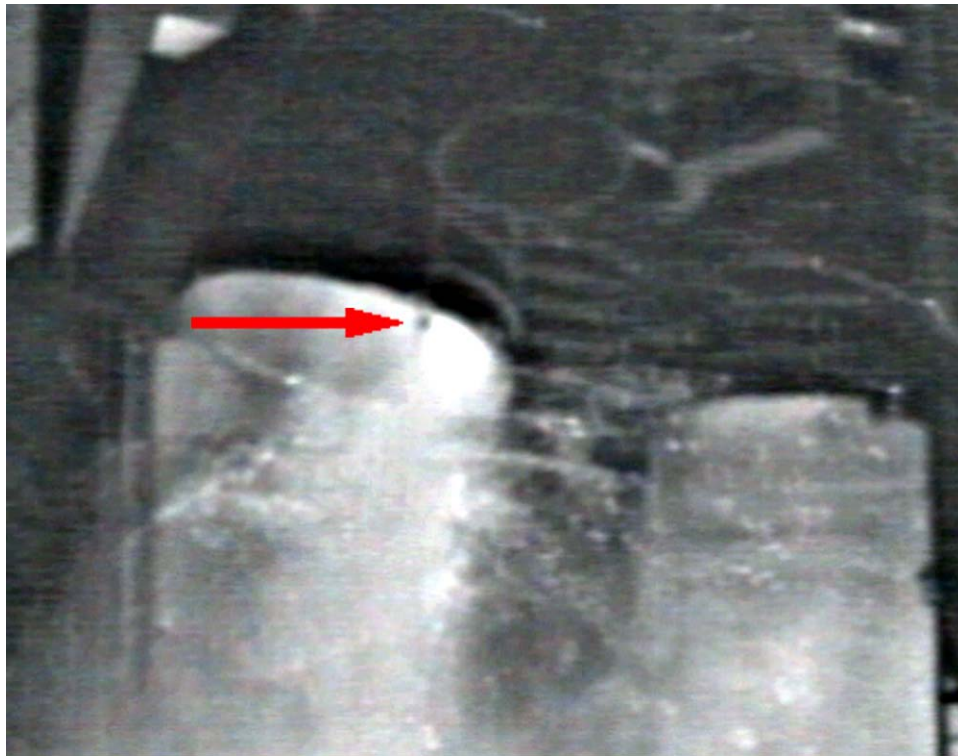
Figure 2.2.1 (A) Ice/frost on SSME #1 Purge Drain Vent (Camera OTV151)

A large ball of ice / frost on a purge drain line vent on the rim of SSME #1 was seen to break loose and fall aft during SSME ignition (09:03:54.131 UTC). (Cameras OTV151, E19, E76)

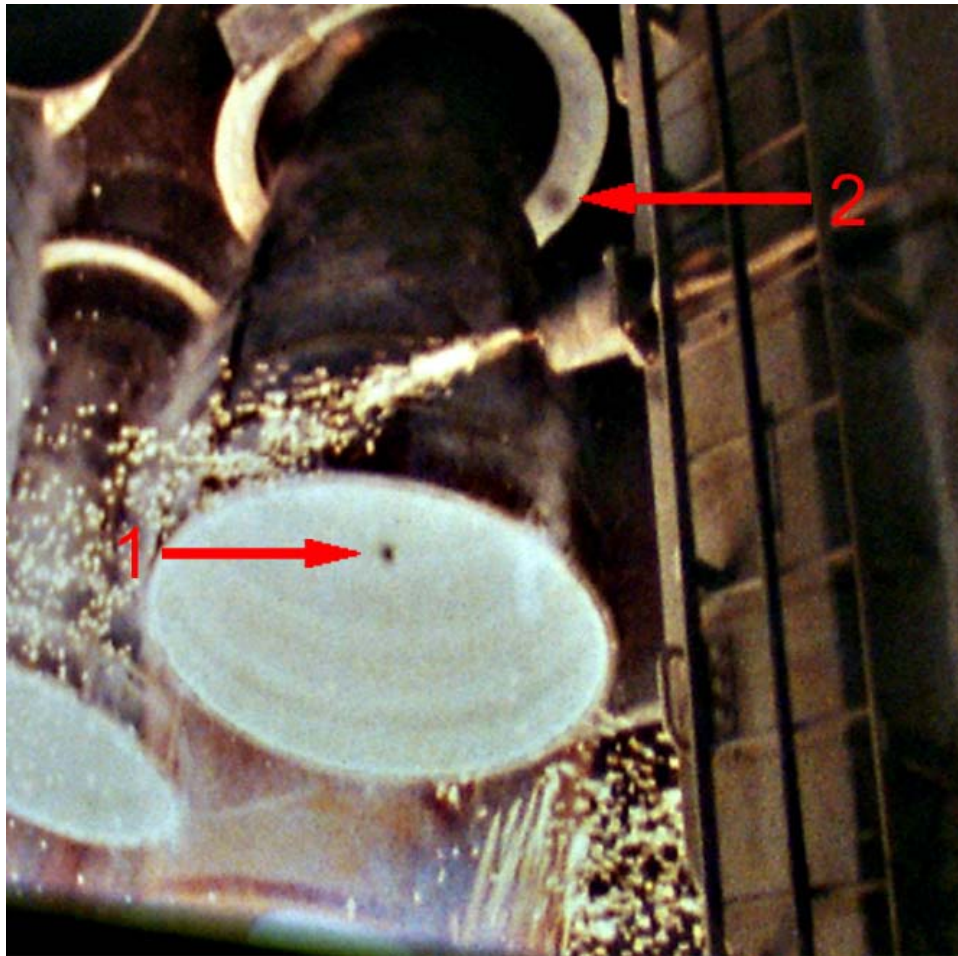
Figure 2.2.1(B) Debris near SSME#3 (Camera E19)

An unidentified, small, dark-colored piece of debris was seen near the right OMS nozzle falling diagonally aft and passing along the +Z side of SSME # 3 prior to liftoff. See Figure 2.2.1(B), annotation 1. The shadow of the debris appeared to be visible on the base heat shield (09:03:56.198 UTC). See Figure 2.2.1(B), annotation 2. (Camera E19)

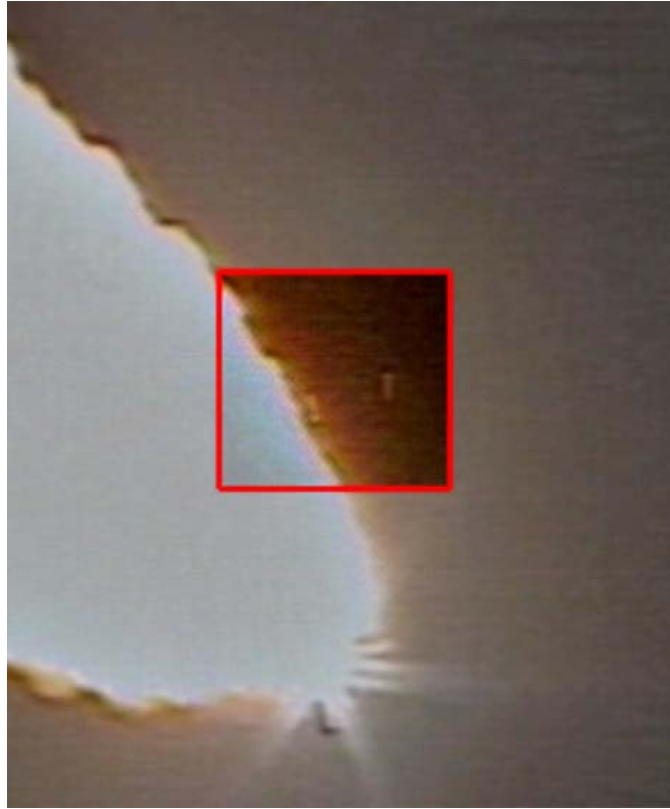
Figure 2.2.2(A) Debris Seen Exiting the SRB Exhaust Plume (Camera KTV4B)

As on previous missions, debris was seen exiting the SRB exhaust plumes. The debris exiting the SRB exhaust plumes during the majority of the ascent was probably instafoam from the aft end of the SRB's. The more dense appearing debris near the time of tail-off, just prior to SRB separation, was probably SRB slag debris (Cameras KTV4B, ET204, E52, E207, E223, E224). Examples are:
